## **Pollution watch report – Mullaloo beach 25<sup>th</sup> November 2023**

### **Introduction**

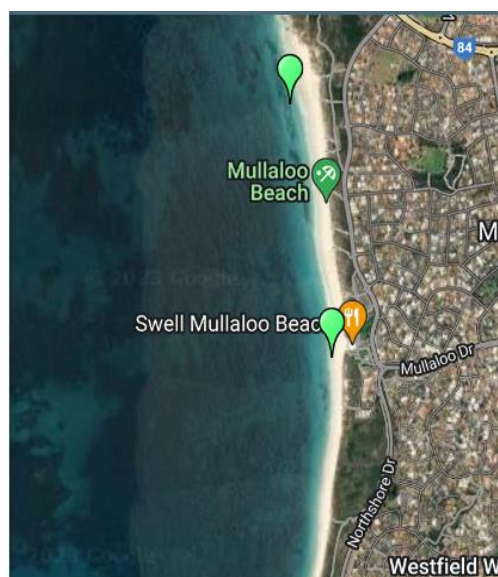
Illustrated sampling points – Beach grade sampling.

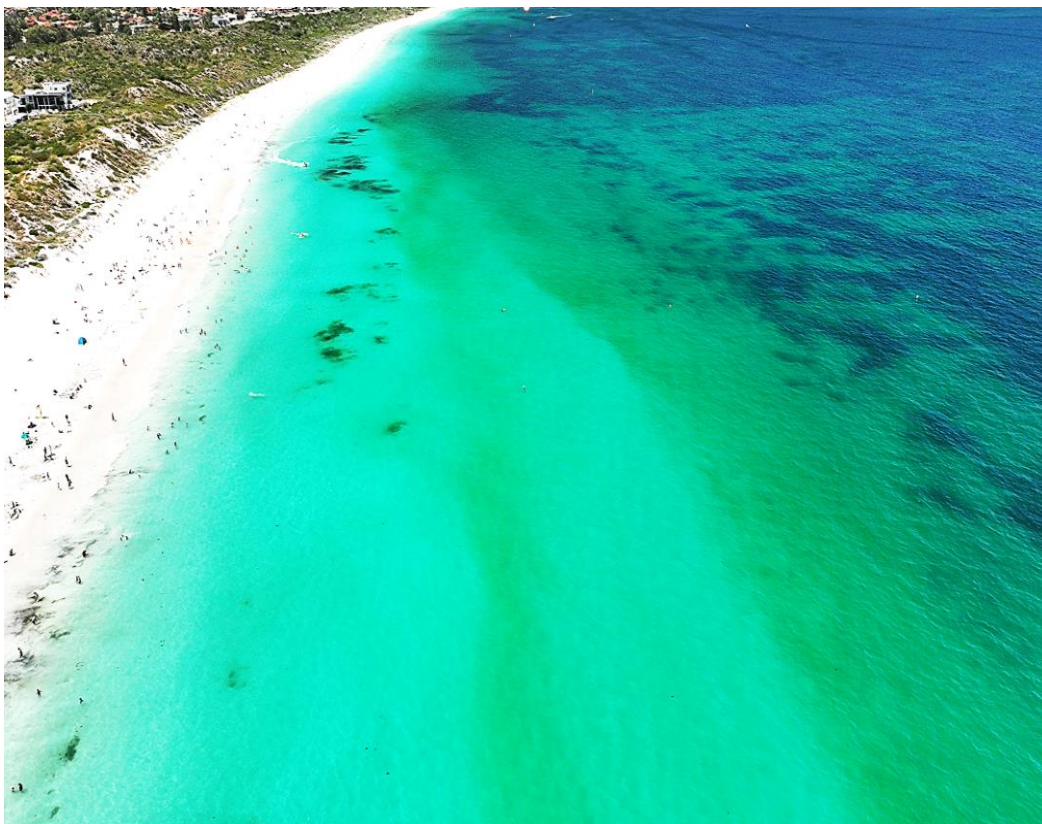
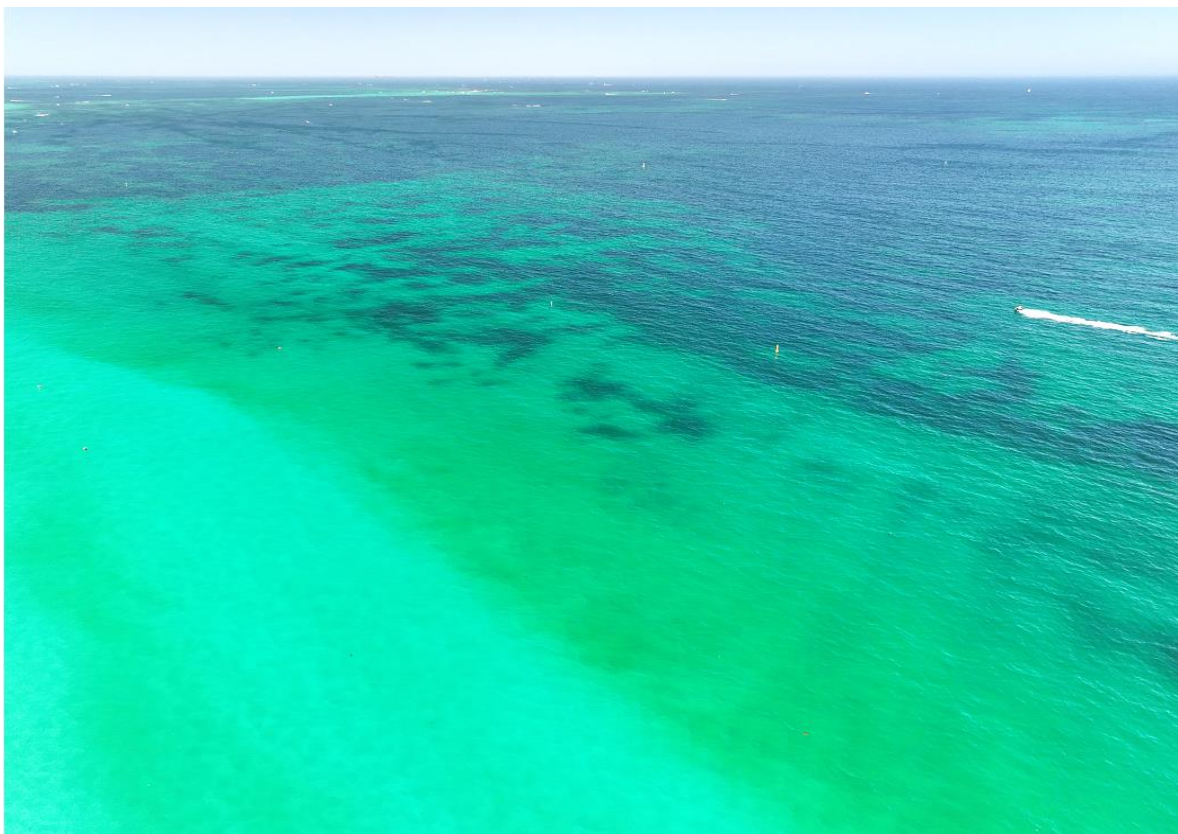
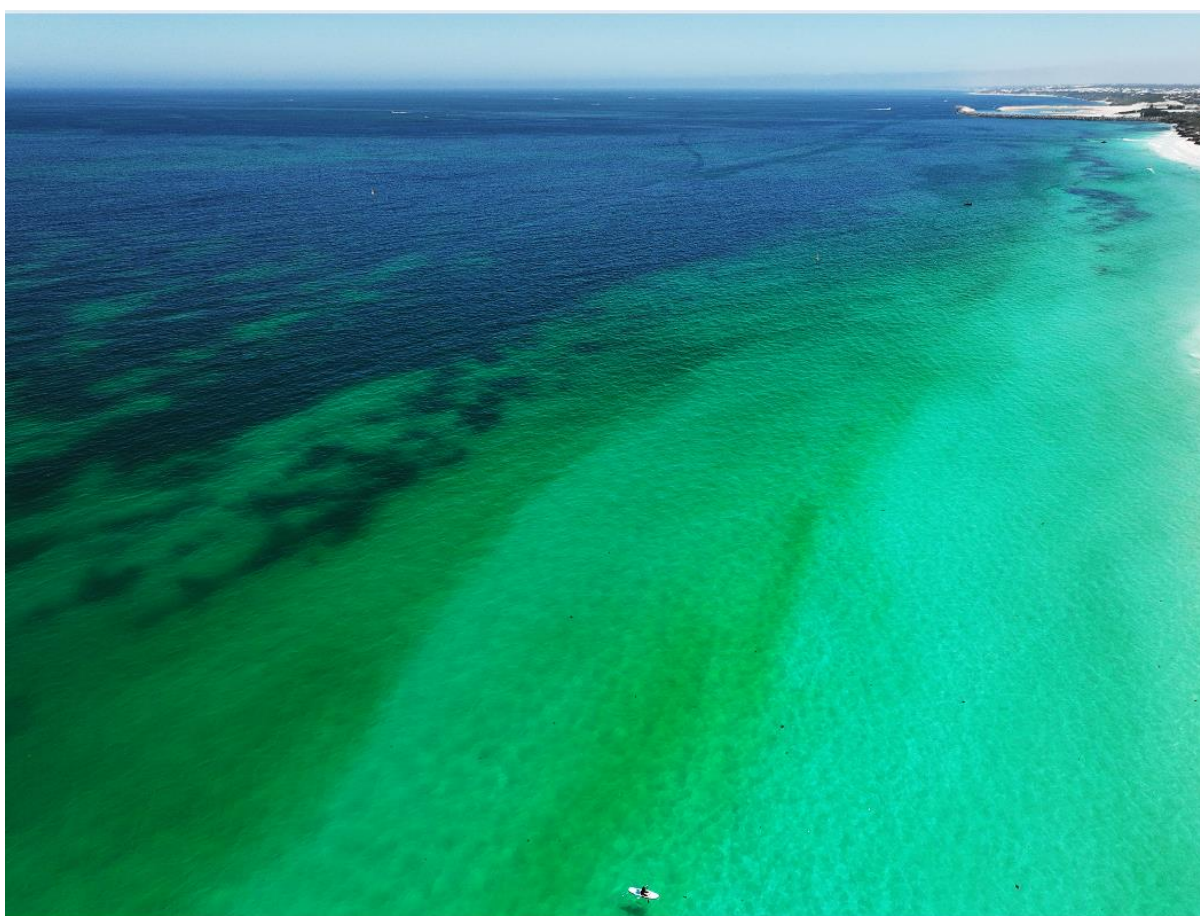
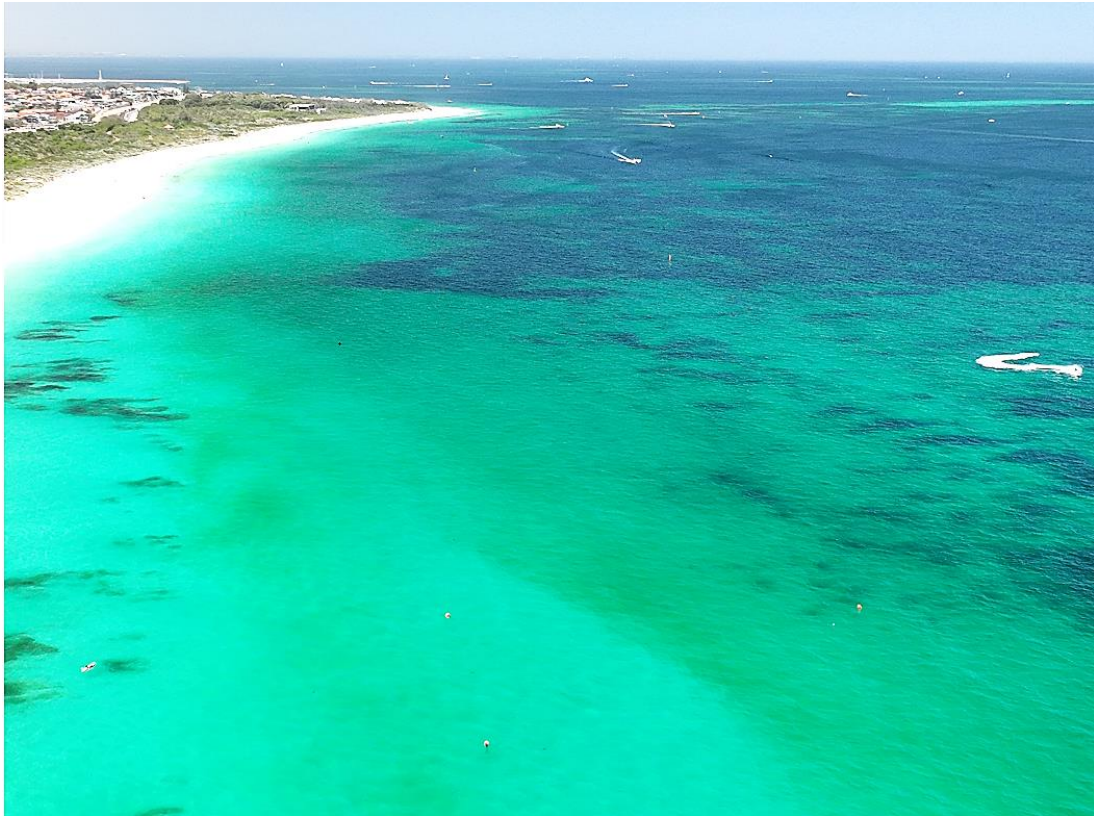
Oily slick along the surface along a large stretch of Mullaloo beach. Reduced visibility in the upper water column (< 1 metre), sweet pungent smell similar to previous morning events.

Clear drone photographic evidence of significant suspended matter along the beach moving in from offshore.

Following are some drone images for the suspended sediments along the coastline at Mullaloo beach.

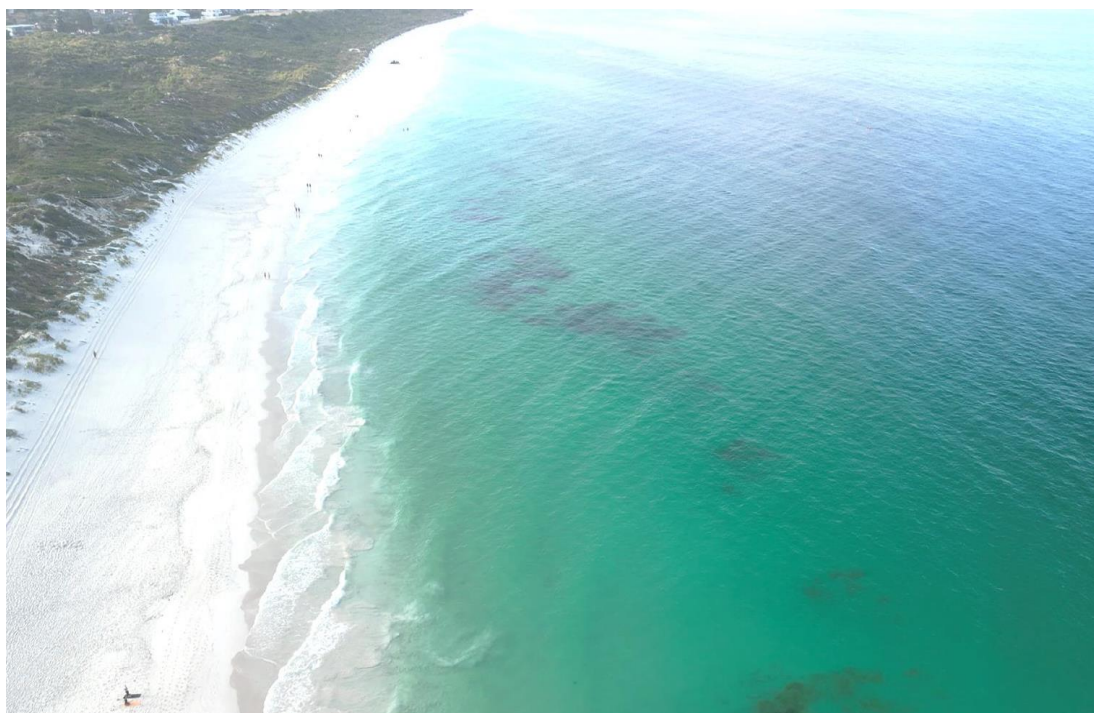
On Friday 24<sup>th</sup>, the water conditions were perfect, drone imagery saw no suspended sediments. For around two weeks prior to today, water conditions have been perfect and drone imagery has seen excellent visibility with no sign of any sediments or particulate matters.

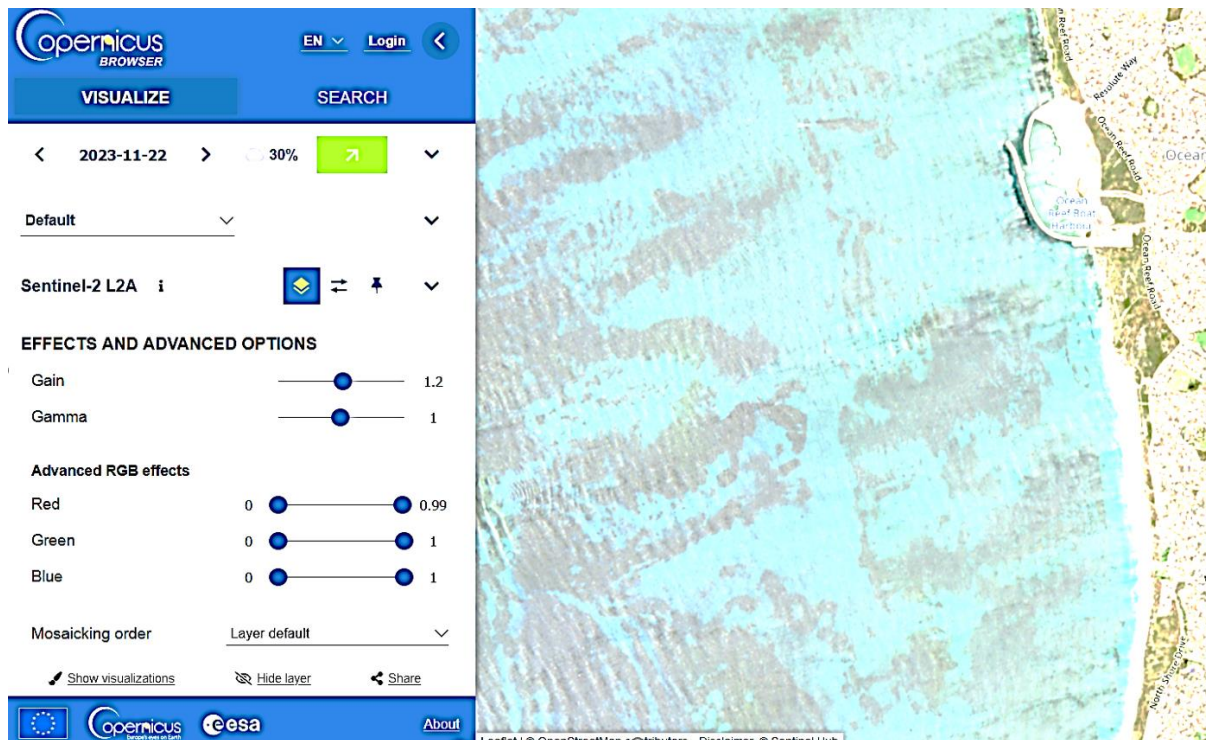
Furthermore, the satellite imagery from the morning of 22<sup>nd</sup> November illustrated perfect clarity.

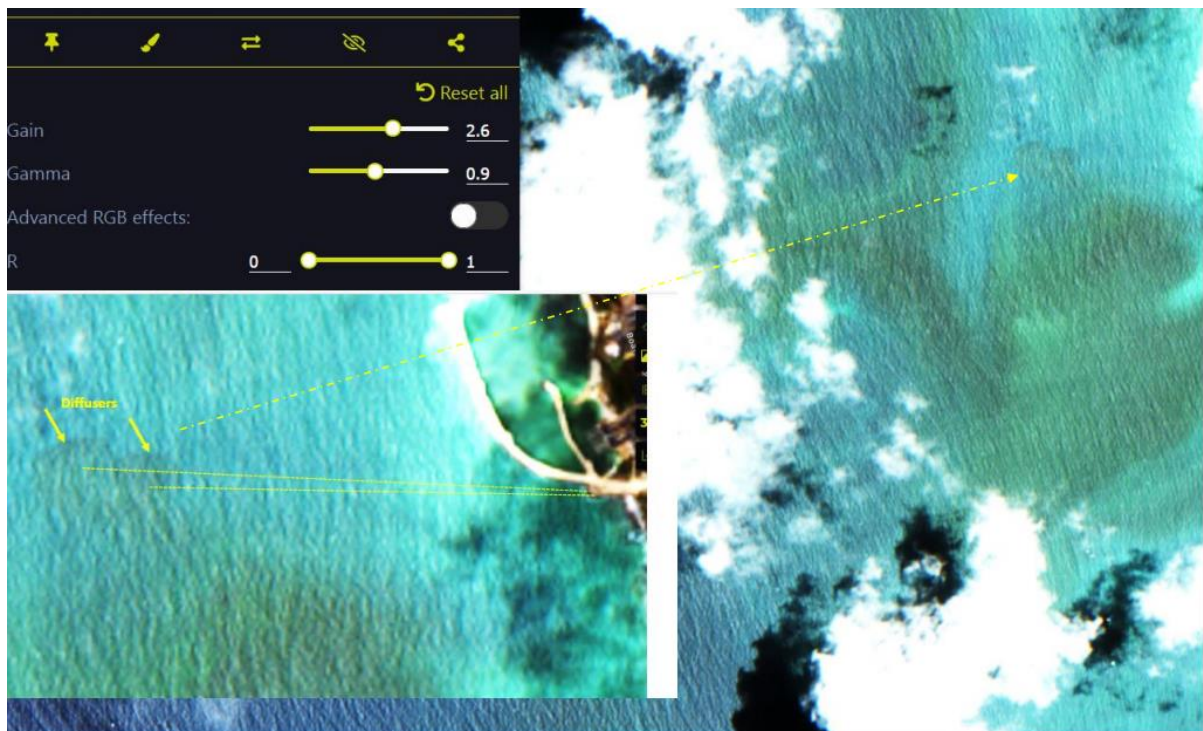
Satellite image showing plume from the outfall tracking towards Mullaloo beach.

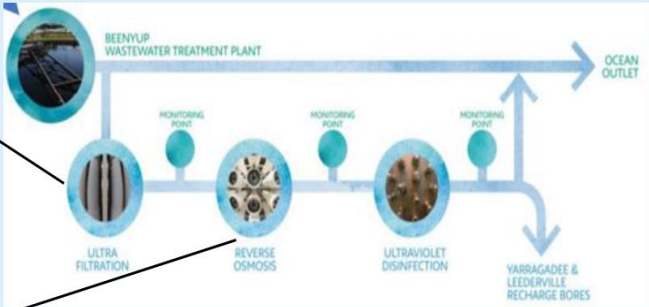
Fouling of both UF and RO membranes and cells is inevitable because of organic, inorganic, and biological constituents, as these plaques build up efficiency decreases and energy use increases. This means that regular flushing and cleaning is required which means that this contaminants are flushed into the marine park.

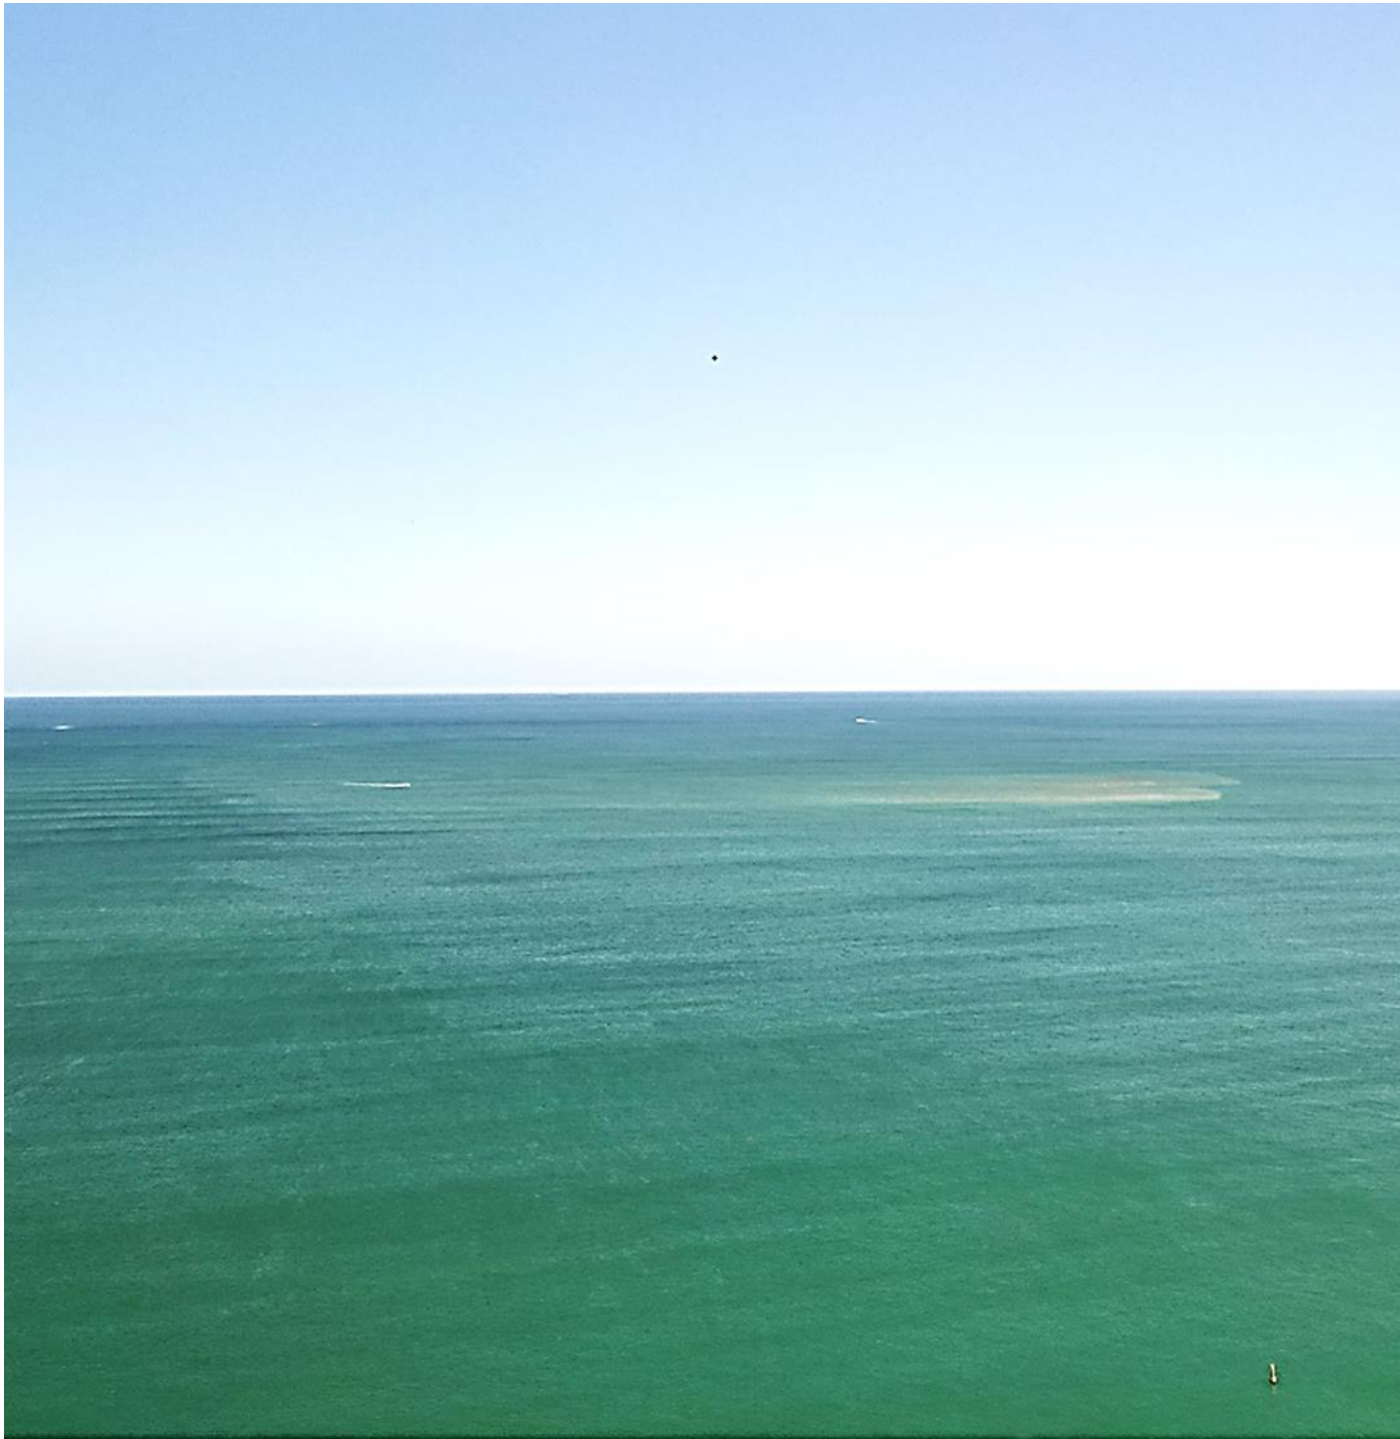
This illustrates what appears to be a daytime flushing event. Over a number of hours this surface plume continued to extend well in excess of the claimed zone of impact in the “Notional” projection in the ministerial statement.
